# **Recent Experience Restoring Damaged Transmission Lines by National Power Corporation of the Philippines**

R. "Rex" F. Corpuz  
National Power Corp.  
Philippines

Paul Erickson, PE  
Lindsey Mfg. Co.  
USA

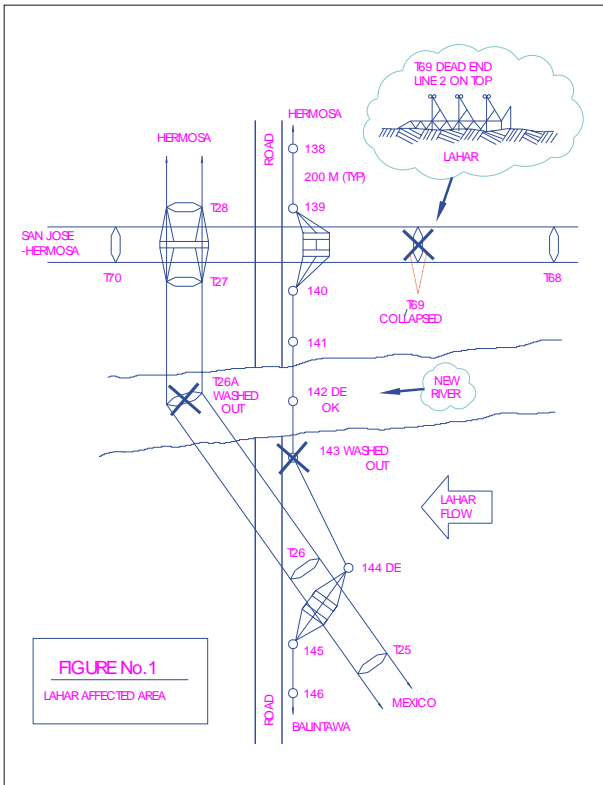
In October 1995 after a heavy tropical storm, a large flow of lahar (a mixture of ash and water from Mount Pinatubo) destroyed five circuits of 230kV transmission lines that supplied the city of Manila (Reference 2). At that time these five circuits carried an average 1200Mw of power to Manila. Figure 1 shows a plan view of the five circuits affected by the lahar flow.

The drawing to the left shows the lahar flow from right to left. Tower T26A on the Hermosa-Mexico and tower 143 on the Hermosa –Balintawak lines were washed away. Tower T69 on the San Jose-Hermosa line collapsed. All other towers were buried in 6-8m of lahar mud.

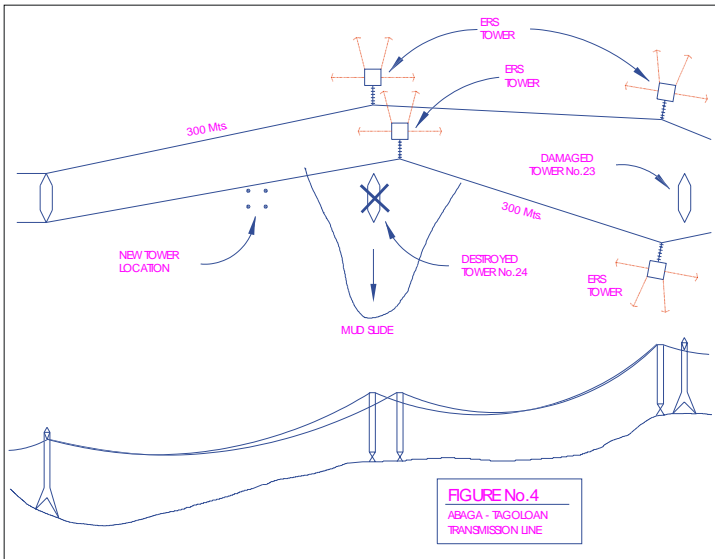
Figure 4

In October of 1996, heavy rains caused a massive mud slide that completely destroyed a full tension tower No. 24 and damaged a cross arm on suspension tower No. 23 on the Abaga-Tagoloan double circuit 138kV transmission line. A plan and elevation of the failure site is shown in figure 4.

The drawing above shows the placement of the four ERS horizontal-vee structures. The mud slide destroyed tower No. 24 and damaged a suspension arm on tower No.23.

Mr. Roberto Marzo, transmission line manager, and Mr. Simeon Clerigo, Lanao area manager, were responsible for the restoration of this critical transmission line. It was decided to restore both circuits with four horizontal-vee ERS structures. Due to the remote location, all ERS material had to be hand carried the last 2km to the site of the land slide. The four horizontal-vee ERS structures were built in five days using an aluminum gin pole and a small portable capstan hoist. The foundation of the ERS was placed on the sloping and unstable soil of the mud slide. It took an additional two days to transfer the conductor, figure 5 shows one of the circuits transferred and the ERS for the second circuit under construction. Both circuits were re-energized in seven days.

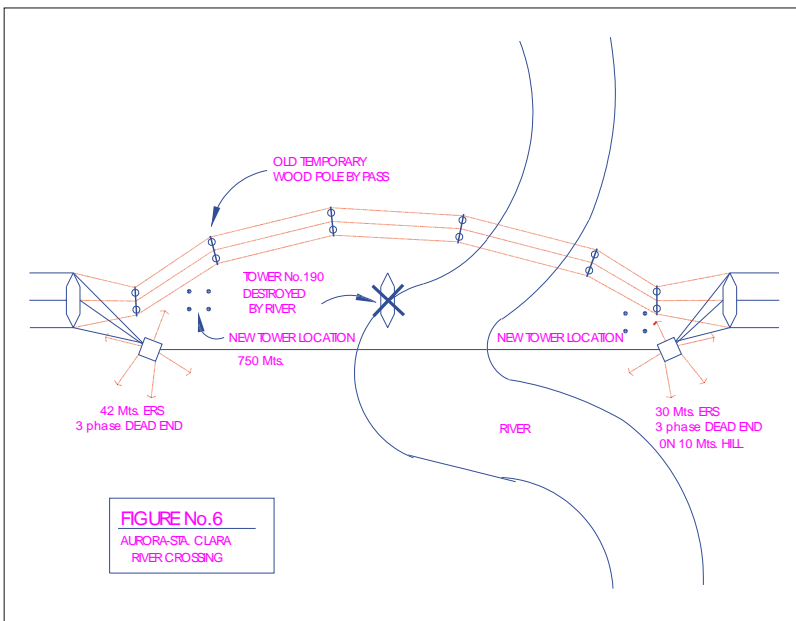
Figure 6

In September 1997, swollen and flooding rivers threatened a wood pole bypass on the Aurora-Sta. Clara single circuit 138kV, a radial feeder in western Mindanao. A year earlier the flooding river had destroyed a river crossing tower No. 190. At that time a

bypass was built utilizing six wood pole H-frame type structures. One year later the wood pole structures were failing for the same reason, the flooding and meandering river was washing out their foundations.

A 750m river crossing was constructed using two ERS tension structures. One was built 42m tall and the other, which was on a hill, only needed to be 30m tall.

Mr. Ruben Conti, transmission line manager, and Mr. Lorrymir S. Adasa, North Western Mindanao area manager, were given the responsibility of building a new bypass that would allow construction of new permanent river crossing towers. It was decided to install two full tension ERS structures to span the approximately 750m river crossing. Due to the span a 43m tall ERS tension tower was required in order to maintain clearance. A plan view of the ERS bypass is shown in figure 6.

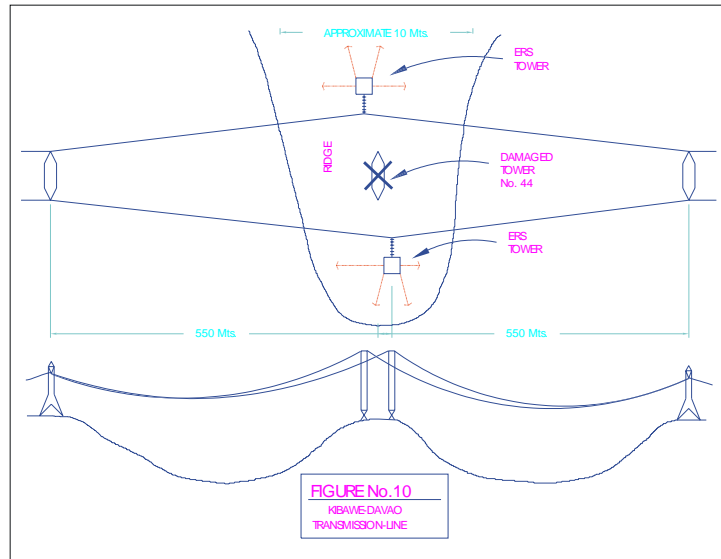
Figure 10

Vandals cut two legs on a double circuit 138kV tension tower, No. 44, on the radial feed Kibawe-Davao transmission line. The tower listed at a 45° angle but did not topple. NPC braced the tower with several guy wires in order to maintain the energized line. This line is a radial feed into a major city and could not be de-energized. When one circuit was de-energized, a 50 megawatt diesel had to be started up in order to maintain voltage at the load center. To complicate matters, the tower was located on the top of a narrow ridge, and the only access to the site was by helicopter. The plan and elevation of tower No. 44 is shown in Figure 10.

Vandals cut the legs of tension tower No. 44. This tower is located on the top of a narrow ridge. In order to keep the line energized, the conductor from one circuit was transferred to the ERS horizontal-vee structures while the other circuit was energized.

Mr. Ernesto Guinares, transmission line manager, and Mr. Emy Abellanosa, North Central Mindanao area manager, were given the responsibility of repairing this tower while always keeping one circuit energized. Their solution was to use two ERS horizontal vee temporary towers to bypass both circuits around the damaged tower. With these in place, the damaged tower could be replaced, as the foundation was not damaged. Access to this site was difficult. All line crews and equipment had to be flown in by helicopter. It took one day and 18 trips (of 20km each) to get all personnel and equipment to the site. Helicopters were required to fly in supplies everyday and the line crew camped at the site. Approximately 25 linemen were involved. A gin pole and small portable capstan hoist were used to construct each ERS horizontal vee tower. The horizontal vee towers were offset longitudinally from the damaged tower approximately 5 to 10ft on either side. Since the site was on top of a ridge, the back and side guys on the ERS horizontal-vees were two to three times longer than normal, as can be seen in figure 11. In order to minimize outage time of transferring conductor from the lattice tower to the ERS

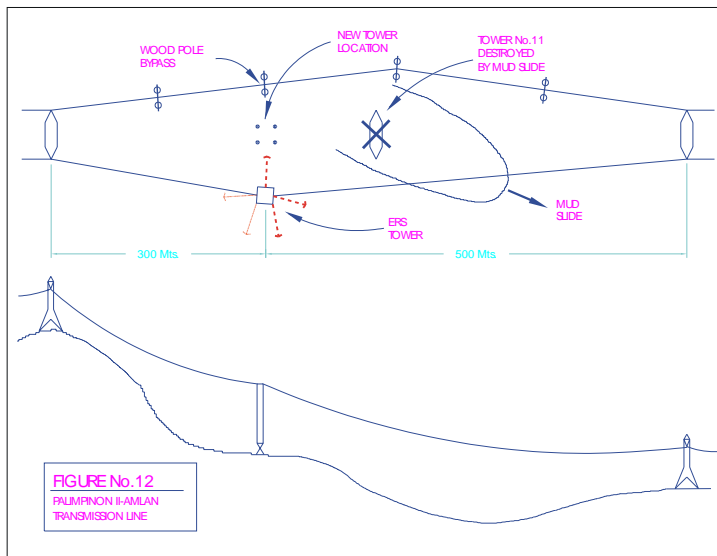
Figure 12

Mud slides destroyed tower No. 11 on the Palimpinon II-Amlan transmission line in the Visayas area. An ERS tension structure was erected to restore the second circuit.

Rain and heavy mudslides destroyed a 138kV double circuit suspension tower, Tower No. 11 on the Palimpinon II-Amlan transmission line, on the island of Negros, in the Visayas area of the Philippines. A temporary wood pole bypass had been constructed; however, this single circuit bypass was heavily loaded and was being threatened again by the mudslide.

Mr. Alfredo Arzaga, transmission line manager, and Mr. Manuel Terez, Central Visayas area manager, were given the responsibility of increasing the reliability of this line. As shown in plan and elevation view of tower No.11, figure 12, it was decided to erect an ERS full tension tower longitudinal, and outside of the mudslide area to carry one circuit of the 138kV line. The site was difficult to erect the ERS since it was located on a sloping hill. A gin pole was used to construct the ERS tension structure, as shown in figure 13. The line crews from the Visayas area used this for a training exercise and erected the ERS structure in only 2 days.
