# TRANSMISSION LINE RESTORATION TECHNIQUES IN COLOMBIA, SOUTH AMERICA

**Mario Aristizabal**  
Transmission Line Engineer  
Interconexión Eléctrica SA  
Medellin, Colombia, South America

## Abstract

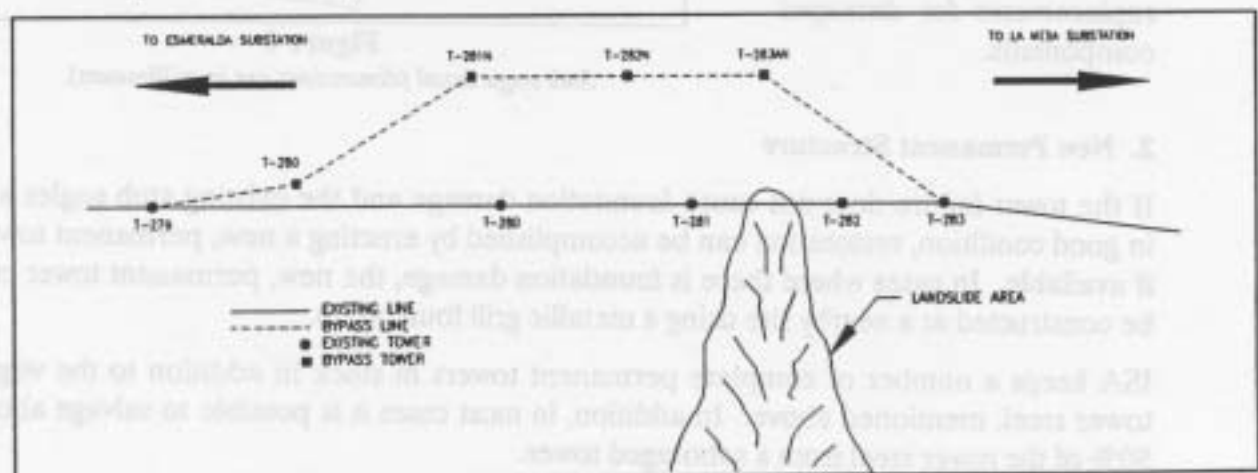
**Figure 3**

In a number of areas, problems with soil erosion and landslides have made it necessary to reroute the transmission line around problem areas (Figure 3). In less severe cases, wood, concrete and metallic retaining walls have been constructed to stabilize the area around tower footings. ISA has also planted new vegetation and built special drainage ducts on some slopes in an attempt to stabilize the soil.

*Due to a landslide affecting the stability of Tower 281, a bypass restoration was built.*

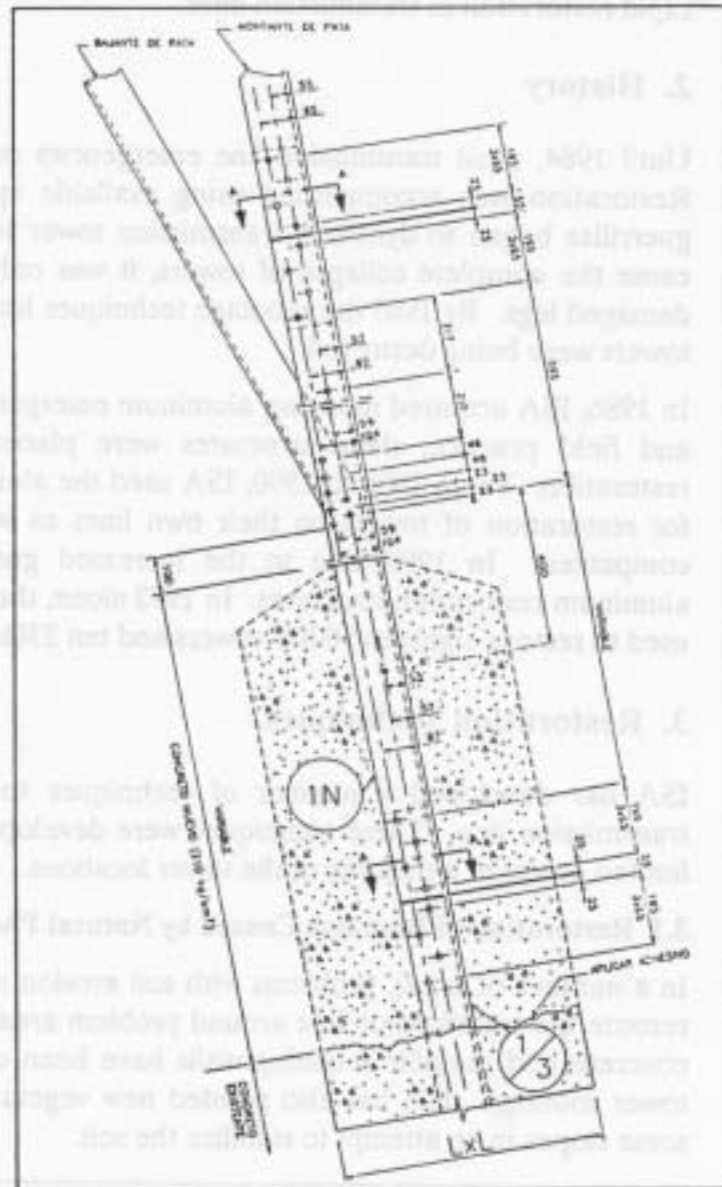
**Figure 4**

In cases where the damage to a structure is not sufficient to cause complete collapse, restoration can be accomplished by repairing the damaged tower steel. ISA constructs the tower stub angles with a spliced connection in the upper portion of the footings (Figure 4). With this type of construction, repair can be accomplished by chipping away only the upper portion of the footing and replacing the damaged stub angle. ISA also maintains a supply of virgin tower steel, particularly material that is not readily available in Colombia, to rapidly fabricate replacements for damaged components.

*Stub angle detail (dimensions are in millimeters).*

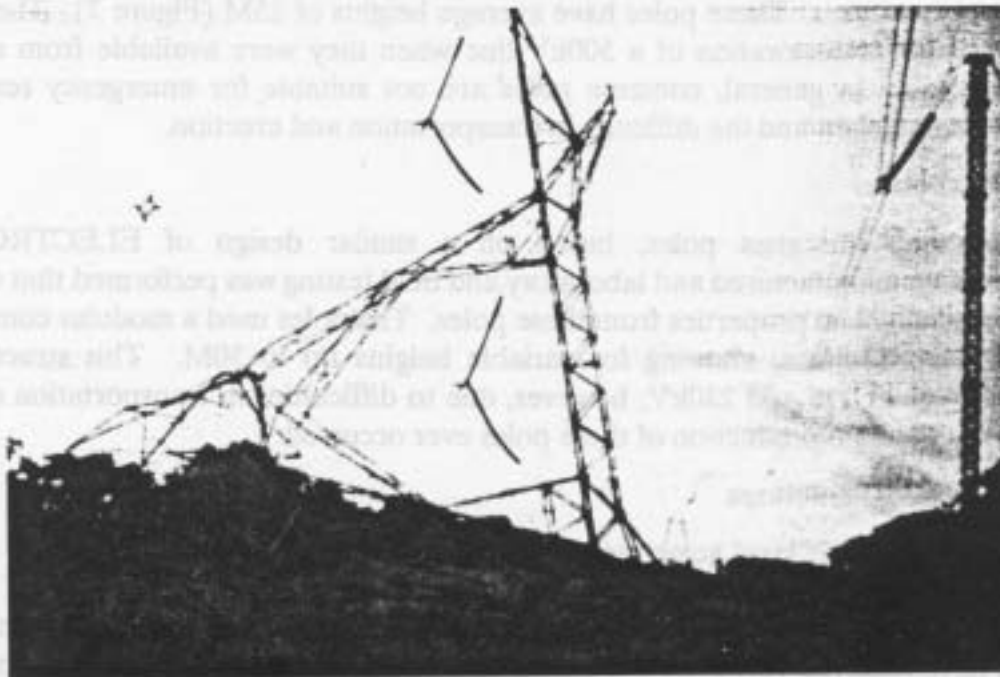
**Figure 5**

One of the first alternatives considered, especially at remote and inaccessible tower sites, is to leave as many phases as possible in service on the downed tower. For example, on double circuit towers that fall transversely, the upper circuit can often be left in service. On a single circuit tower, one and sometimes two phases can be left on the failed tower and reenergized, with only the one phase actually in contact with the ground being moved to a temporary structure (Figure 5). In some cases, fiberglass rods or insulators are used to limit the conductor motion and insure that all required clearances are maintained. If needed, the collapsed tower is stabilized with guy wires.

*Utilization of the collapsed tower for temporary restoration.*

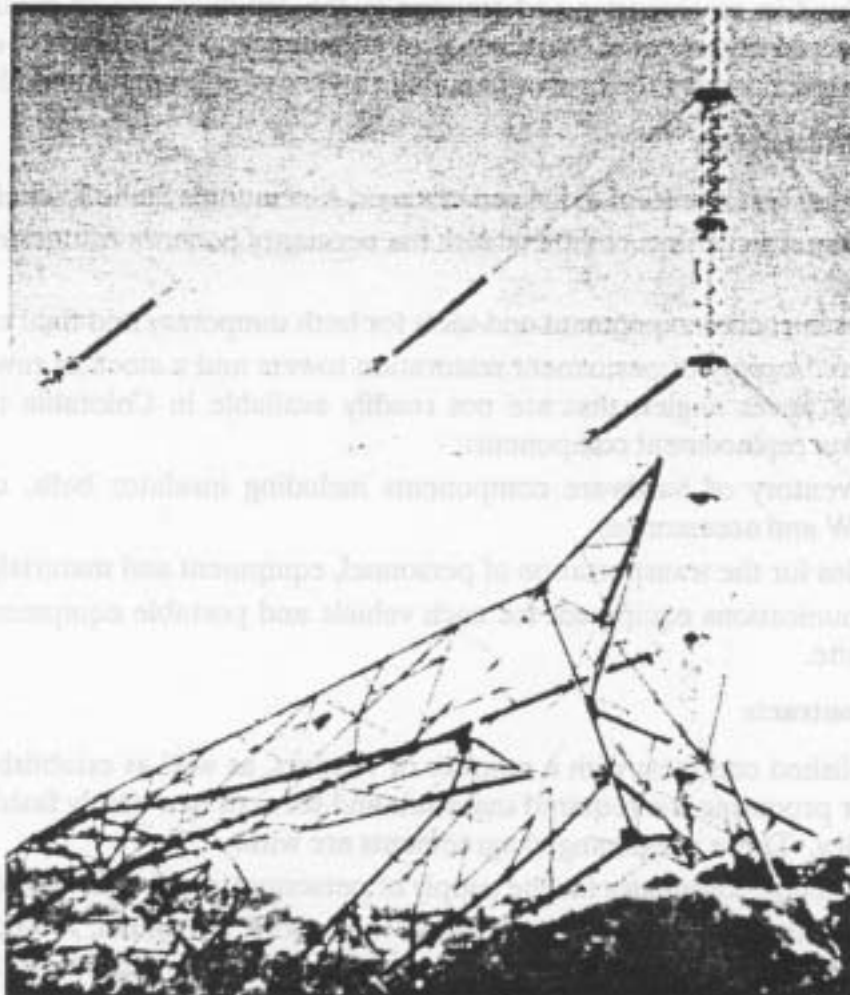
**Figure 10**

*ISA has designed a number of unique configurations using the modular, aluminum restoration structures, including this 500kV three phase running angle structure used to restore a sabotaged 90° tension structure. To get an idea of the scale, note the lineman working on the outer conductor bundle.*
