TRANSMISSION LINE EMERGENCY RESTORATION PHILOSOPHY AT LOS ANGELES DEPARTMENT OF WATER AND POWER

R. J. SCHWEINER K. E. TWOMEY
Los Angeles Department of Water and Power

K. E. LINDSEY*
Lindsey Manufacturing Co.

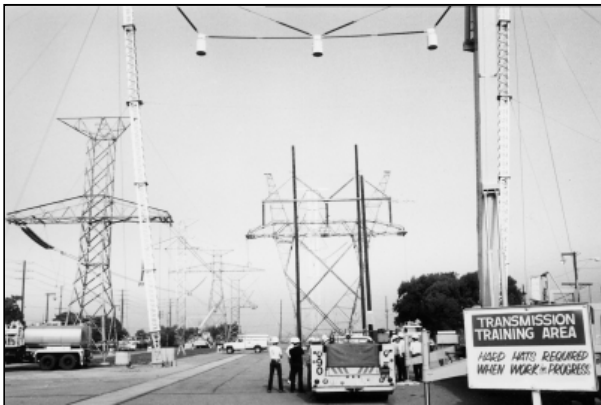
Figure 2

This LADWP training facility enables TC&M crews to train in all phases of construction and maintenance. Various DC, AC and temporary towers are erected.

Transmission patrolmen get approximately 80 to 100 hours of classroom and field training per year at TC&M's training facility (see figure 2). However, much of the training is on the job training, since TC&M crews perform capital improvement jobs, such as, transmission line modifications, fiber optic installations as well as normal maintenance including live line maintenance on all transmission lines voltages. The TC&M line crews can and do build towers and string conductor on a regular basis.

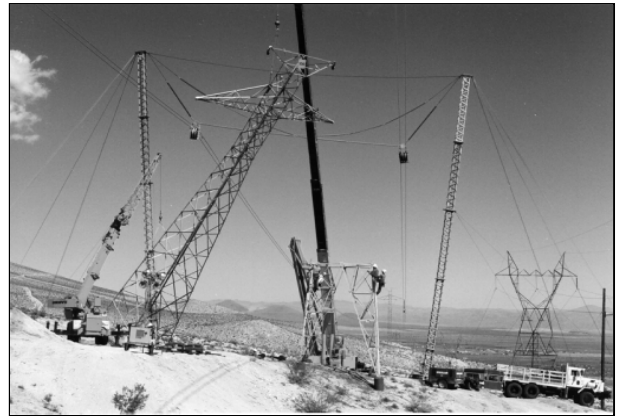
Figure 4

Permanent restoration of a self-supporting DC Intertie tower. The de-energized conductors are supported in the ERS, and the Owens line is shown at the right.

The permanent restoration of the DC Intertie was contingent on delivery of self-supporting tower steel, and the availability of DC Intertie. During the week of March 27, the northern crew transported the tower steel to the

Indian Wells site and assembled the tower for erection, completing the restoration (see figure 4).

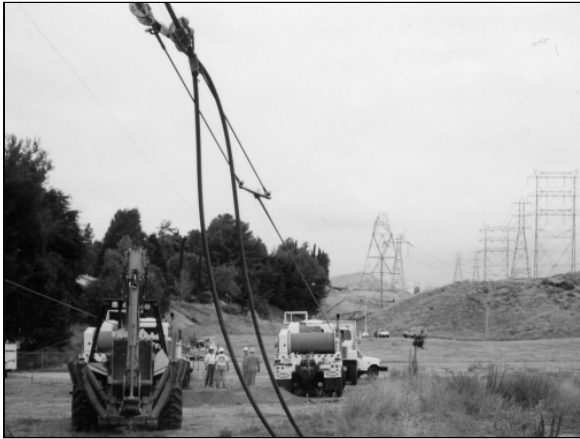
Figure 5

Snubbing the twin bundle 2312kcmil conductor with conductor grips and a winch truck. Note the residential area to the left of the damaged tower.

LADWP crews immediately responded. They grounded and snubbed the conductor to prevent further damage (see figure 5), and a roadway under the line was barricaded for public safety. As a similar self-supporting tower was not available, LADWP crews installed a temporary IEEE Standard 1070 ERS structure. Due to the close proximity of residential houses, a steep down guy angle was required. This was quickly analyzed using the emergency restoration structure structural analysis computer programs.
