PLANNING AND TRAINING REDUCE RESTORATION TIME FOR DAMAGED TRANSMISSION LINES IN INDIA

L. N. Agrawal
Power Grid Corporation of India Ltd.
India

Paul. E. Erickson, P.E.
Lindsey Manufacturing Company
United States

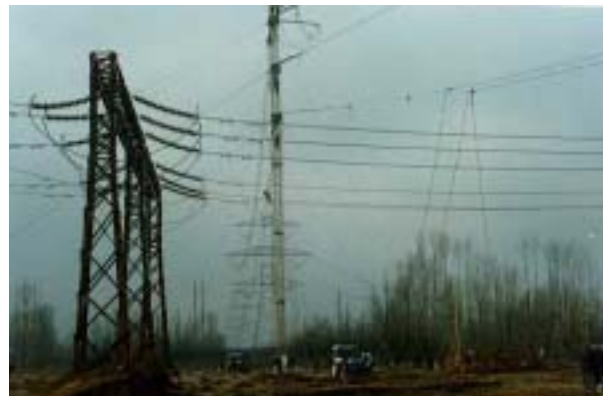
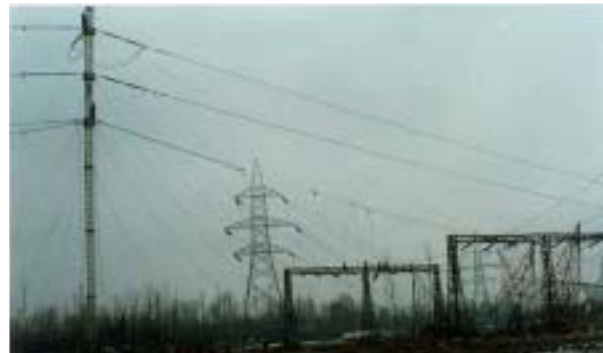
Figure 9
Two views of the almost completed 400kV ERS tension tower showing the span over the double circuit 220kV line.

After transporting the ERS to location no. 268 of the 400kV Uri-Wagoora line, the actual work started on the 19th January under very adverse and cold and snow climate (see figure 8). One 15-degree in-line dead end structure (101 ft. high) supported by 18 guy anchors was used to bypass the damaged tower at location no. 268 (see figure 9). The two conductor bundle spans were 416m on one side and 300m on other side.
