# Transmission Emergency Restoration Systems For Public Power

Dr. Keith E. Lindsey\*

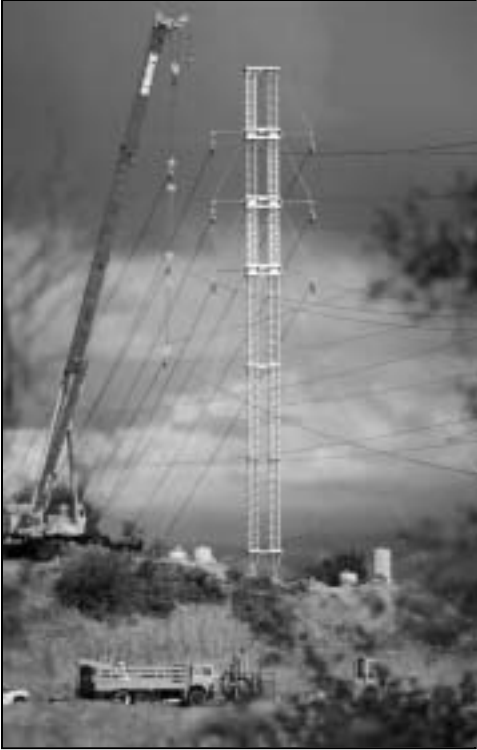
**Figure 3**  
One 230kV circuit at the left is supported by the crane; two other circuits are supported by an IEEE Standard 1070 ERS. This double circuit 230kV ERS structure was designed for a narrow right-of-way.

In order to support the load that was being brought back on line, two more circuits of this critical 230kV line needed to be restored. In order to accomplish this a special double circuit narrow right-of-way ERS structure made from the same IEEE Standard 1070 components was erected next to the energized circuit in the crane (see Figure 3). By the morning of January 19, all three circuits were energized.

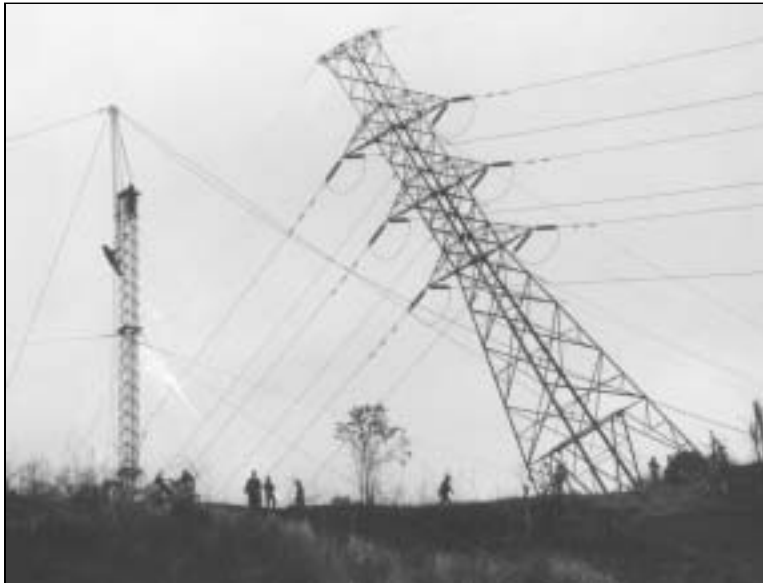
Figure 8  
Vandals cut the legs of tension tower No. 44. This tower is located on the top of a narrow ridge. In order to keep the line energized, the conductor from one circuit was transferred to the ERS horizontal-vee structures while the other circuit was energized.

voltage at the load center. To complicate matters, the tower was located on the top of a narrow ridge, and the only access to the site was by helicopter. See Figure 8.

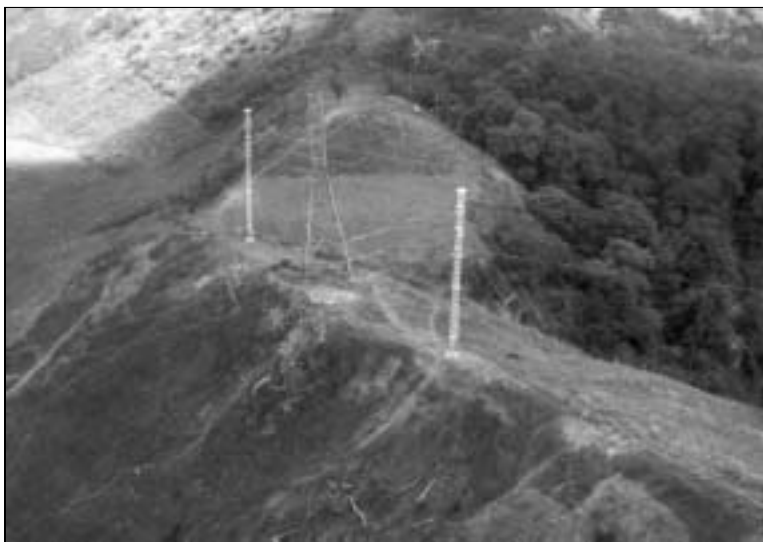
Figure 9  
The photograph to the left shows the placement of the two ERS horizontal-vee structures directly on top of the ridge. Note that the dead-end insulators and hardware are in the span and to the left of the ERS in the foreground.

Two ERS horizontal vee temporary towers were used to bypass both circuits around the damaged tower. With these in place, the damaged tower could be replaced, as the foundation was not damaged. Access to this site was difficult. All line crews and equipment had to be flown in by helicopter. It took one day and 18 trips (of 20km each) to get all personnel and equipment to the site. Helicopters were required to fly in supplies everyday and the line crew camped at the site. Approximately 25 linemen were involved. A gin pole and small portable capstan hoist were used to construct each ERS horizontal vee tower. The horizontal vee towers were offset longitudinally from the damaged tower approximately 2 to 4m on either side. Since the site was on top of a ridge, the back and side guys on the ERS horizontal-vees were two to three times longer than normal, as can be seen in Figure 9.
