# Insulator Extension Arms

## Lindsey Fail-Safe Insulator Base Testing

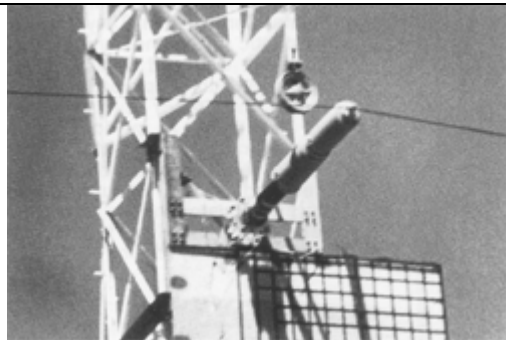
**Figure 4. Tower No. 1 before test.**

In addition to our own tests, independent full scale broken conductor tests have also been performed using these bases. In this test four lattice type towers with span lengths between 650 and 900 feet were equipped with our No. 4036 Fail-Safe Base and a 91 inch long 230 KV simulated insulator stack (see Figures 3 and 4 below).

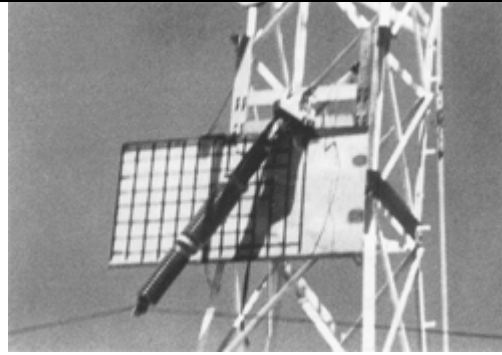
**Figure 6. Tower No. 2 after test.**

3/0 copper conductor was tensioned to 4300 lbs. After the line was cut, the first two bases plastically collapsed without damaging the insulators or dropping the conductor (see Figures 5 and 6). The third base sustained almost no damage (see Figure 7), i.e. the shock waves were almost completely damped out by the third tower due to the ability of the Fail-Safe Bases to plastically deform and absorb much of the strain energy released by a broken conductor (see Figure 8). The insulator stack in this test consisted of two station post insulators (rated at 2800 lbs.) and one pipe section with strain gages attached. The maximum dynamic cantilever loads recorded from these strain gages were 1605 lbs. at the first tower and 1620 lbs. at the second tower. These dynamic loads are well below the initial conductor tension and only slightly above the 1270 lb. static longitudinal fail-safe load of the No. 4036 Base-

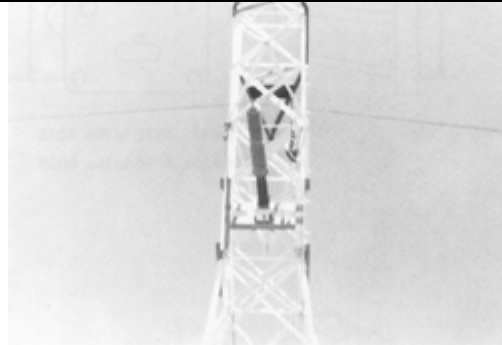
**Figure 7. Tower No. 3 after test.**
