# TRANSMISSION LINE RESTORATION TECHNIQUES IN COLOMBIA, SOUTH AMERICA

**Mario Aristizabal**  
Transmission Line Engineer  
Interconexión Eléctrica SA  
Medellin, Colombia, South America

## Abstract

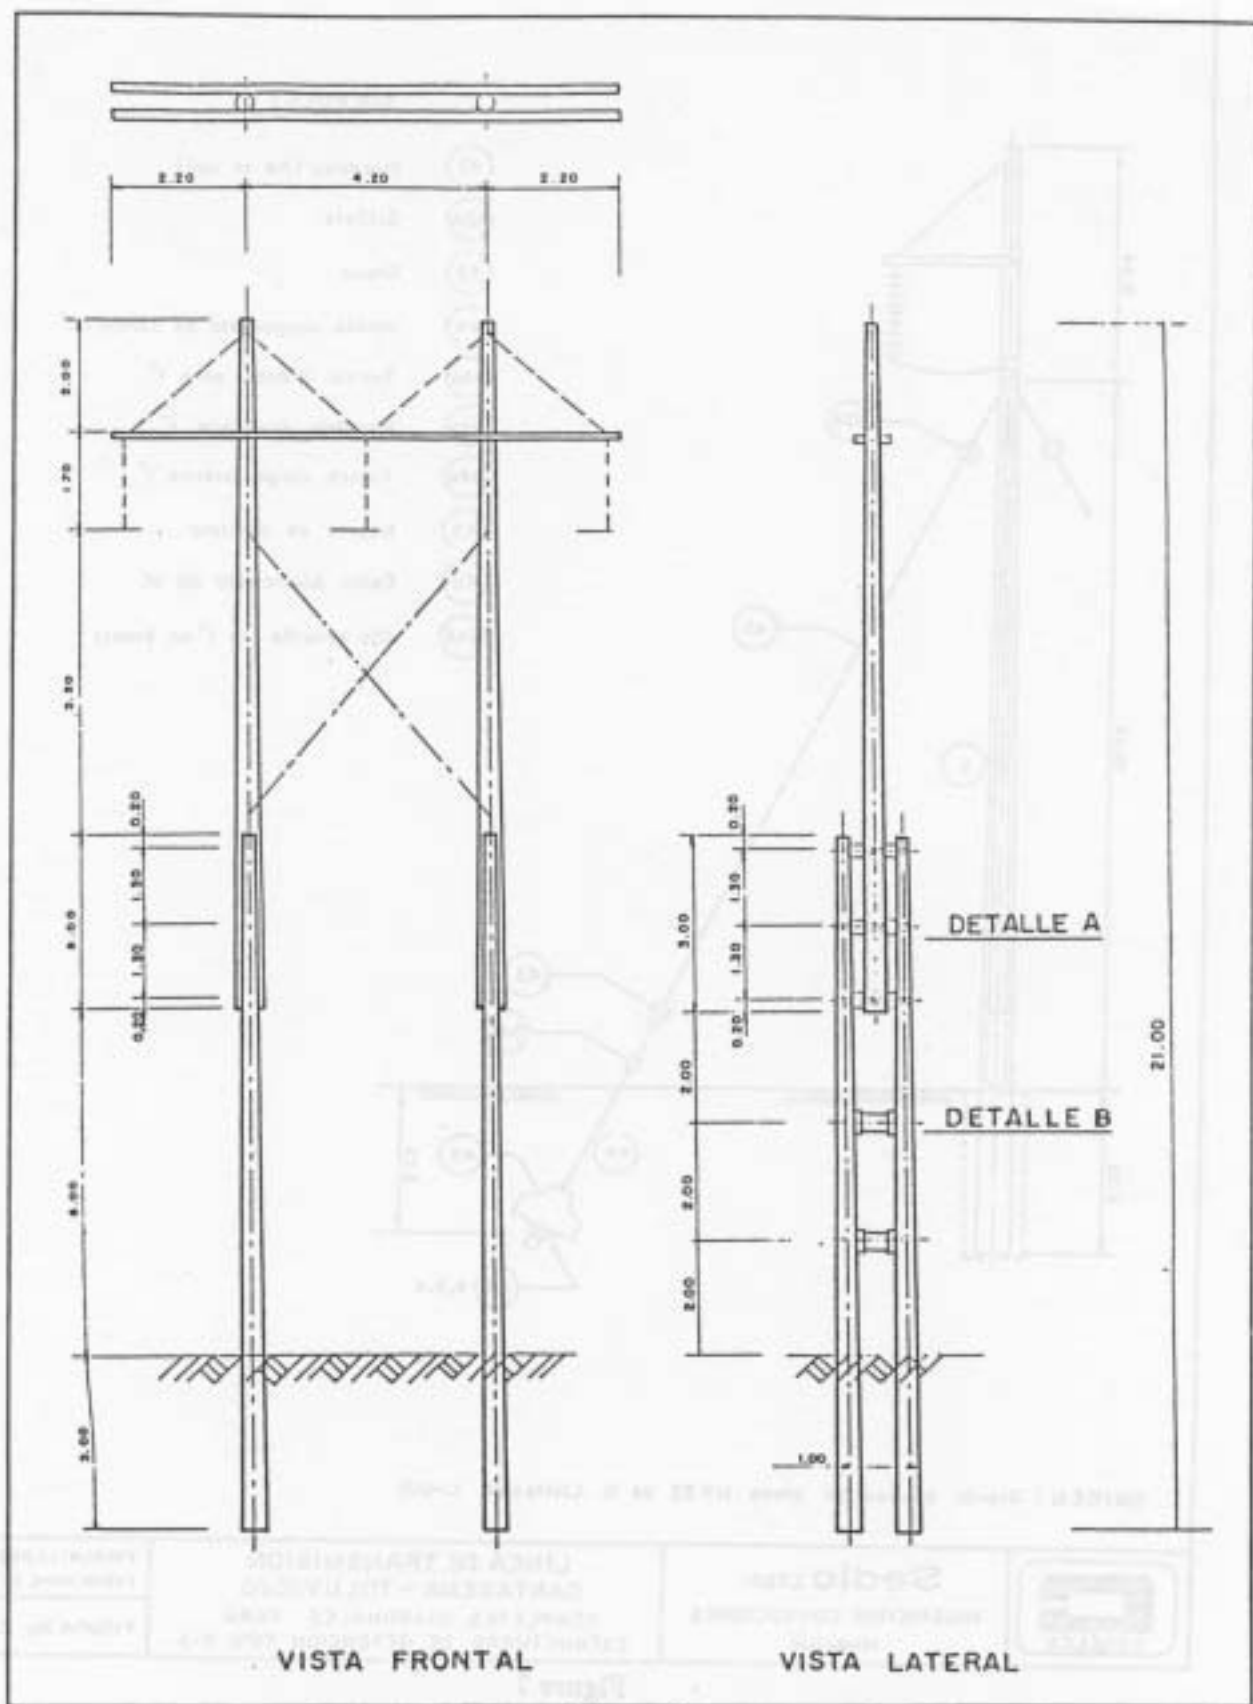
**Figure 6**

Wood poles are frequently used for 115kV lines, generally in a horizontal vee configuration. These poles have a maximum height of 16M and average spans of 80M. For 230kV lines a special H-Frame structure has been designed using poles of 12 and 18M to achieve a structure height of 21 and 28M (Figure 6). Although wood poles are the least expensive alternative, they have relatively limited capacity and they can create transportation and handling problems in the mountainous regions.

*Wood Pole H-Frame Structure (dimensions in meters).*

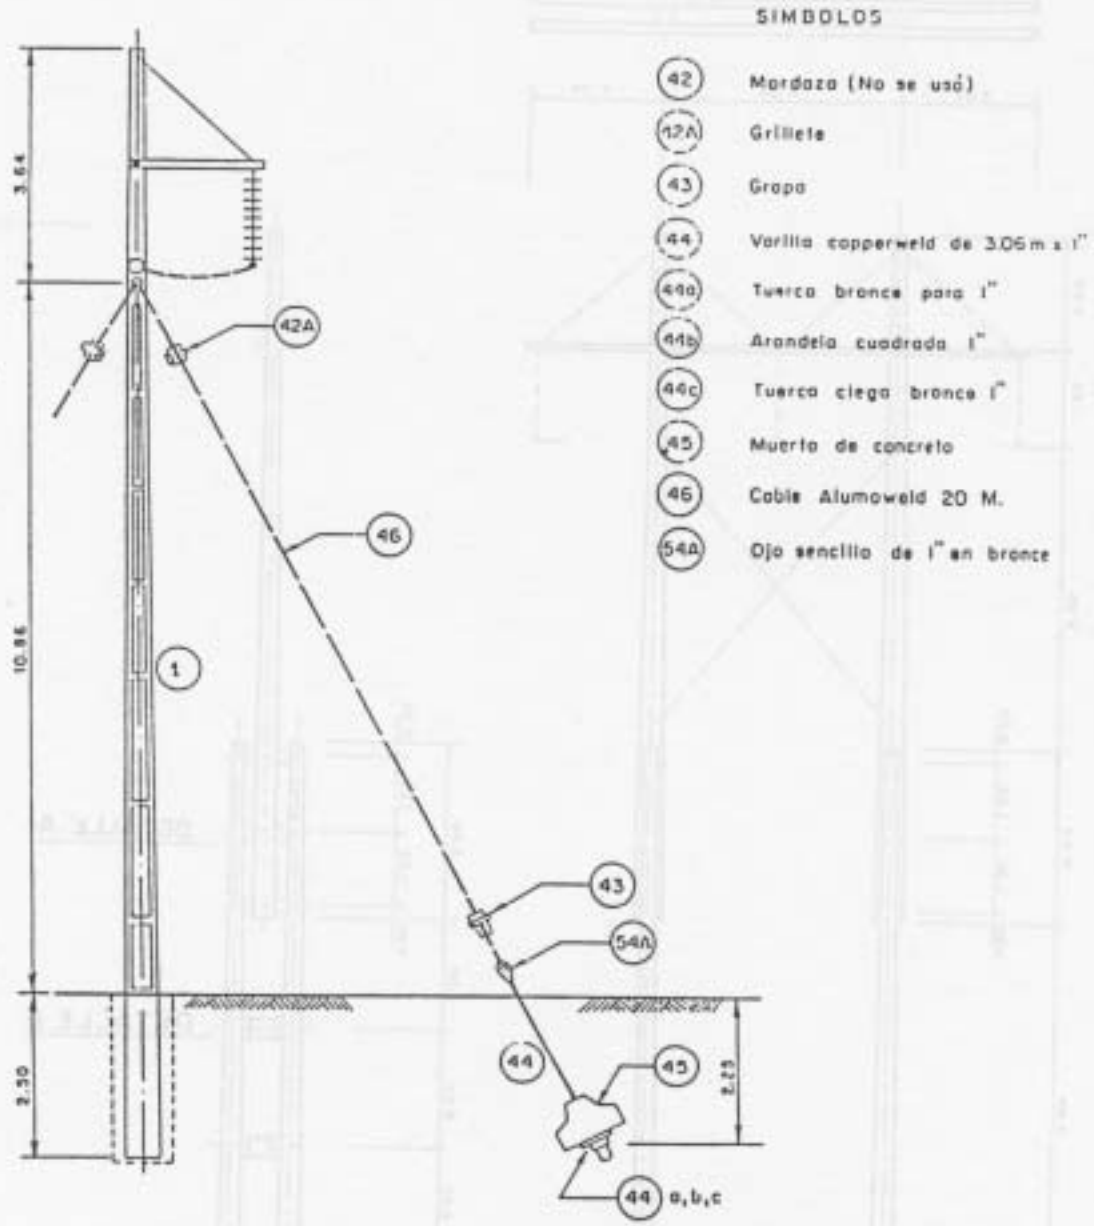
**Figure 7**

Concrete poles are used on 115 and 230kV lines where adequate access roads are available to allow transportation. These poles have average heights of 15M (Figure 7). These poles were once used for restoration of a 500kV line when they were available from a nearby construction job. In general, concrete poles are not suitable for emergency restoration because of their weight and the difficulty in transportation and erection.

Concrete Structure (dimensions in meters).

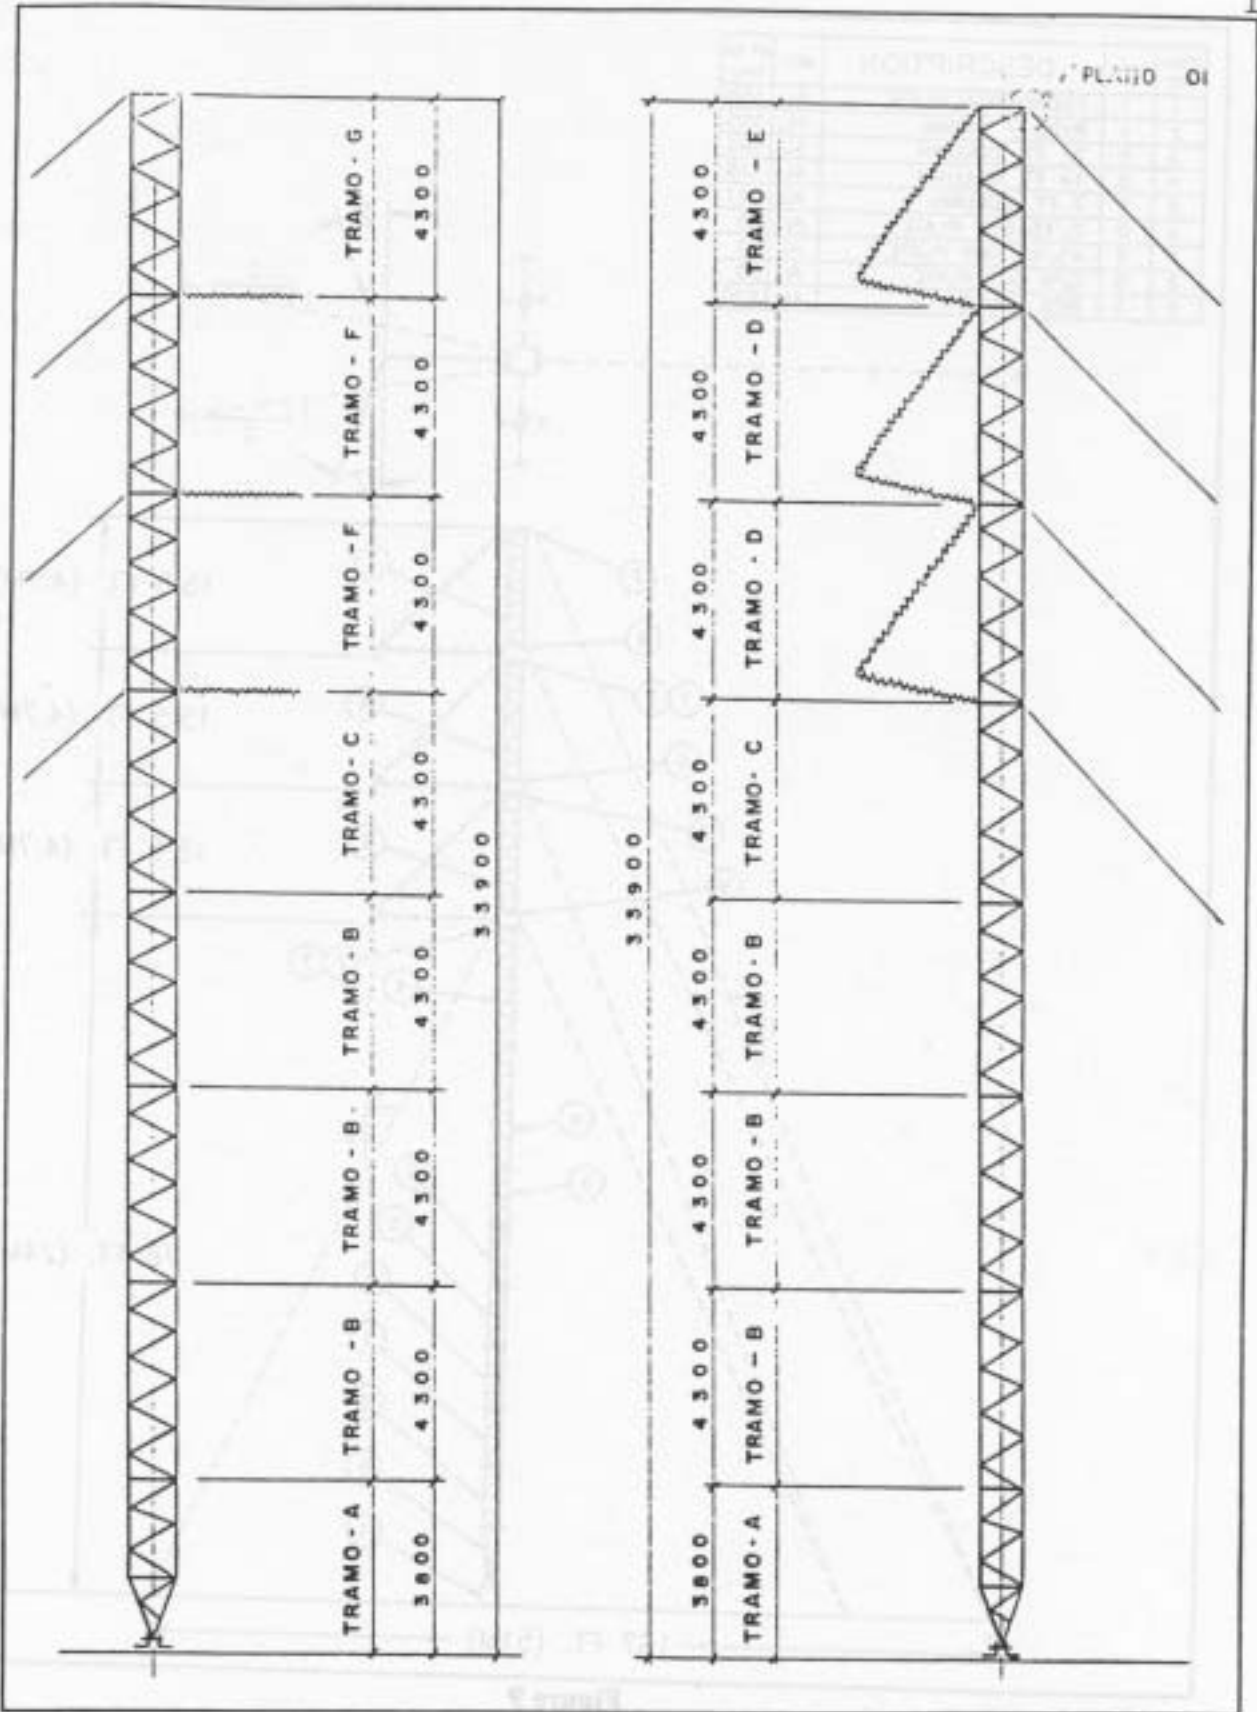
**Figure 8**  
*Modular Steel Structure (dimensions in millimeters).*

A lattice type, modular steel structure was designed and built in Colombia. The modular sections are 4.3M in length, with a maximum structure height of 34M (Figure 8). Column sections are mounted on a hinged base plate, allowing rotation in one direction. These structures have received very little use due to their lack of flexibility and the low confidence in their reliability.

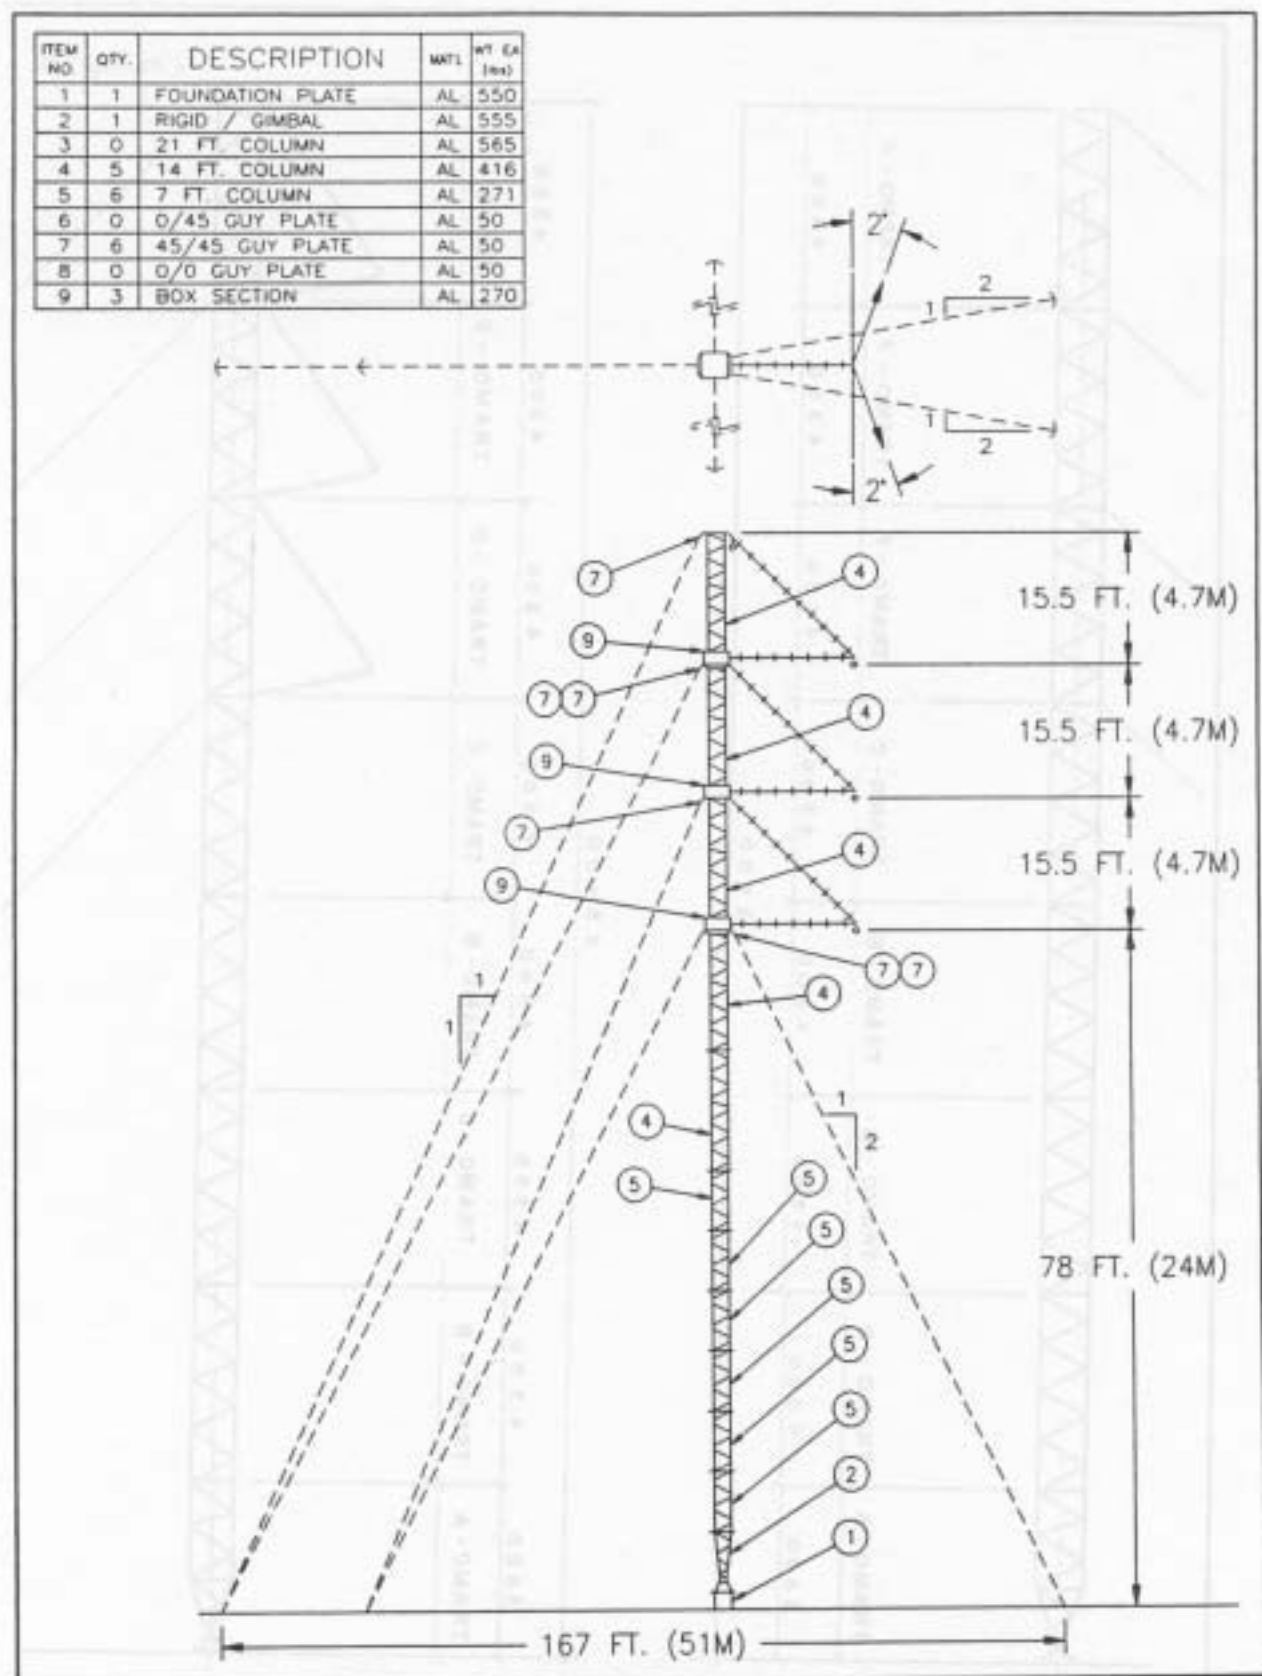
Figure 9

*Modular Aluminum Structure in a Horizontal Vee Configuration*

In order to provide emergency structures for the 500kV line from San Carlos to Sabanalarga, ISA acquired a number of modular, aluminum restoration structures in 1986. These welded aluminum structures are made in modules of 7, 14 and 21 feet, allowing modifications in structure height and design depending on the requirements. The foundation consists of a 1 inch aluminum plate that is placed on the ground. Above the foundation is the gimbal joint that allows universal articulation and reduces the eccentricity of the column loads (Figure 9).
